Manhole Inspection Summary

Manhole # S19I1_006MH

Insp Date: **4/18/08 2:47 PM**

Location Address: **2400 marbourne av**

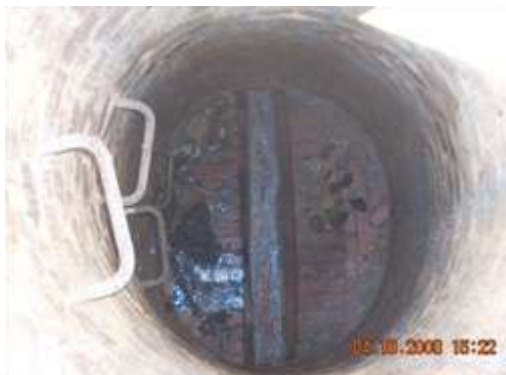
Bench Debris

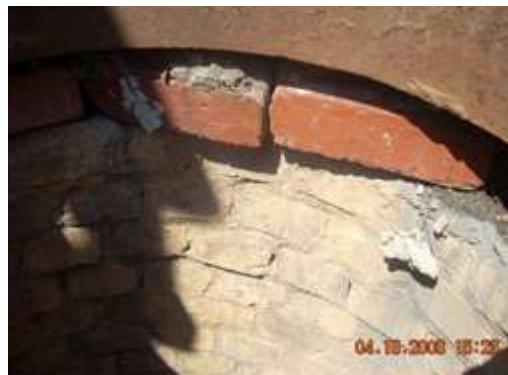
Defect 3

Condition: ☐ Sound ☐ Cracked ☐ Root Intrusion ☒ Loose Brick ☒ Deteriorated

loose chimney bricks

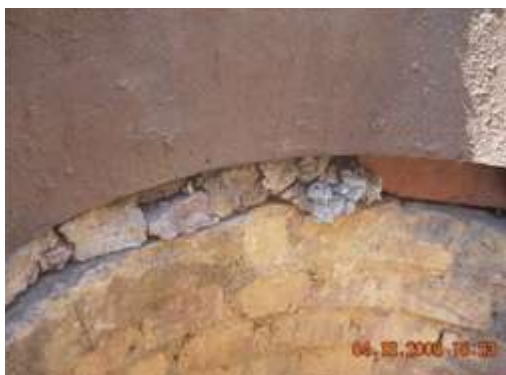
Defect 2

deteriorated chimney

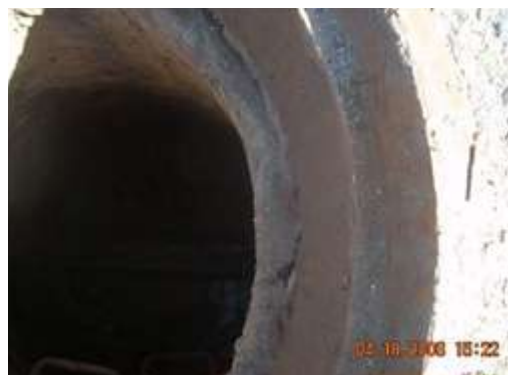
Defect 1

Frame Offset: **1** (in.) Condition: ☒ Sound ☐ Cracked ☐ Leaks

frame offset

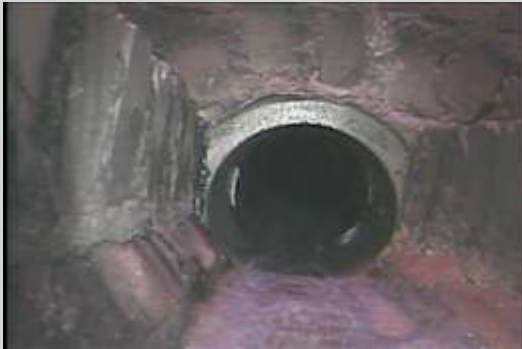
12 O'Clock Outflow

8 in. Circular Gravity Sewer
Pipe Out @ 12 O'Clock

Pipe Height: **8.4** (in.) Rod and Bar (Angled)
Pipe Material: **Clay** ☐ Pipe Lined
Invert Depth: **8.75** (ft.) Flow Characteristics: **Slow**
Deposits: ☒ None ☐ Mud ☐ Sludge ☐ Debris ☐ Grease
Silt Depth: **0** (in.) Deposits Extent:
Infiltration: **None** Pipe Seal Cond: **Sound**

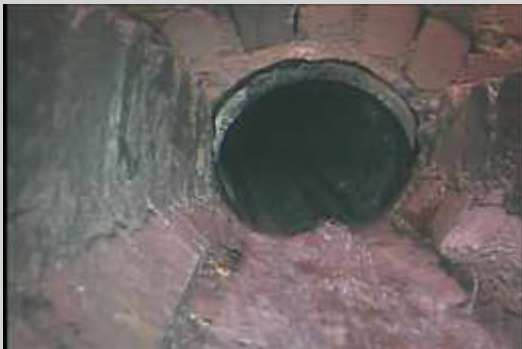
6 O'Clock Inflow

8 in. Circular Gravity Sewer
Pipe In @ 6 O'Clock

Pipe Height: **8.4** (in.) Rod and Bar (Angled)
Pipe Material: **Clay** ☐ Pipe Lined
Invert Depth: **8.52** (ft.) Flow Characteristics: **Fast**
Deposits: ☒ None ☐ Mud ☐ Sludge ☐ Debris ☐ Grease
Silt Depth: **0** (in.) Deposits Extent:
Infiltration: **None** Pipe Seal Cond: **Sound**

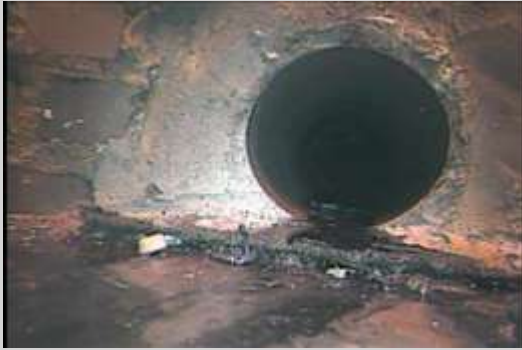
8 O'Clock Inflow

6 in. Circular Gravity Sewer
Pipe In @ 8 O'Clock

Pipe Height: **6** (in.) Rod and Bar (Angled)

Infiltration: **None** Pipe Seal Cond: **Sound**
